# RPC Trigger in CRuZeT 4

Tomasz Früboes

CMS Warsaw Group

August 26, 2008

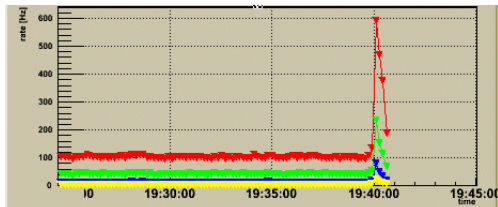
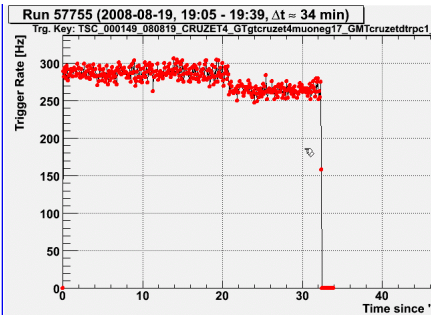
# Trigger rate peaks - destroy/create of trigger configuration

## From trigger ELOG:

run 57755 started

... in LS 13 the muon trigger rate dropped by about 20 Hz to 340 Hz,  
most probably due to a DT problem in some chambers

Run Control stops run

(pause+stop causes problem in trigger, but destroy clears it up)

## Another TTC-RPC crate problem?

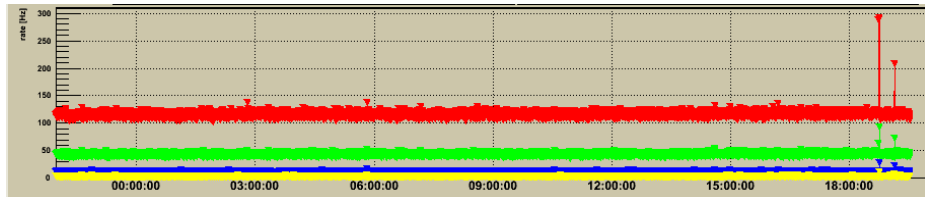
# Trigger rate peaks - high voltage instabilities

Rate peaked from  $\sim 100$  Hz to  $\sim 300$  Hz. From RPC ELOG:

Subject: W-2 S4\_Rb3- trip  
At 18.50 the chamber tripped with no clear reason.  
We tried to ramp again but it doesn't reach 8000 V.  
It is now off.

HV in this chamber was back before 8PM (second rate peak)
